WATERSHED SURVEY REPORT
MESSALONSKEE LAKE (AKA SNOW POND)
Oakland, Belgrade & Sidney, Maine

JANUARY 2022

MESSALONSKEE LAKE WATERSHED SURVEY REPORT

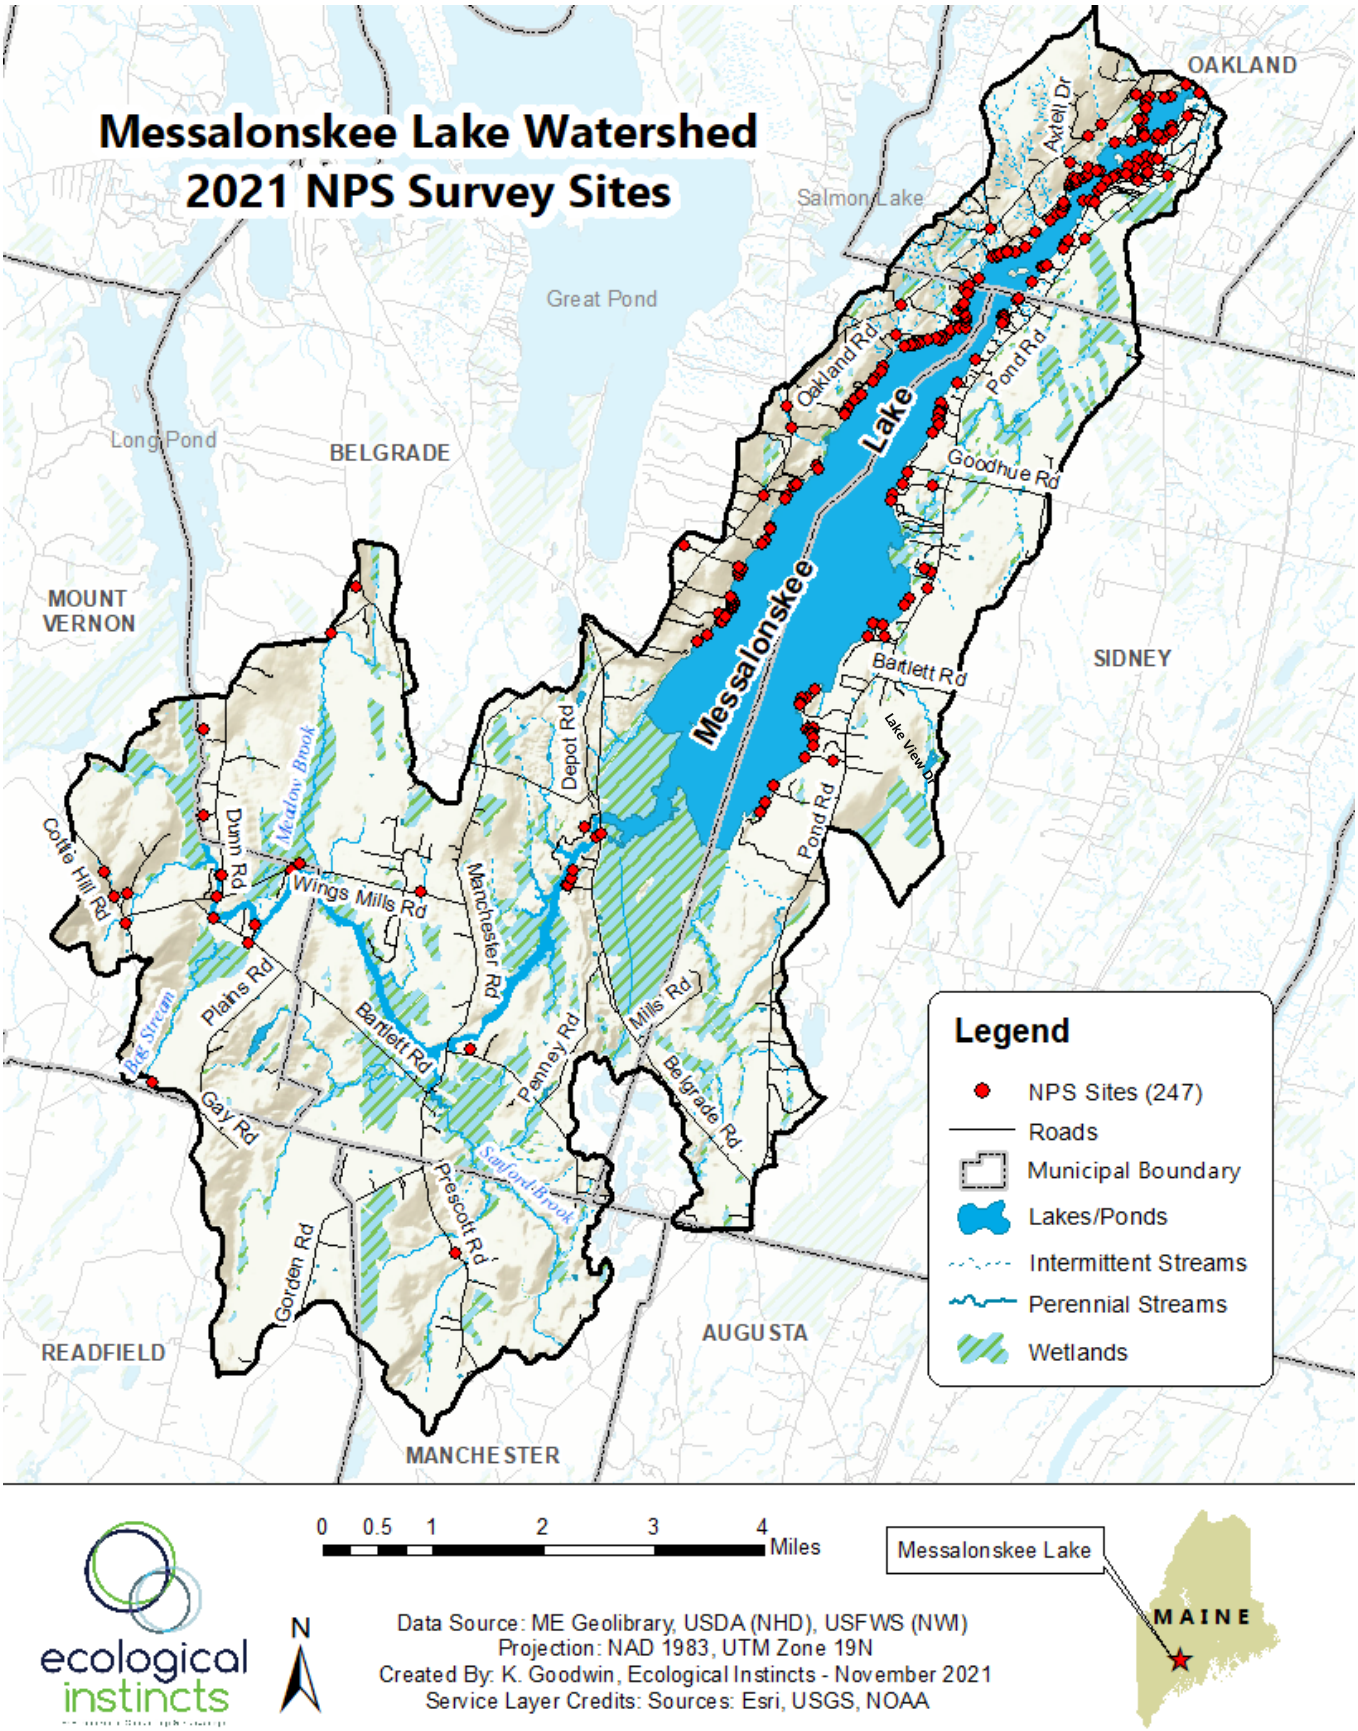
Figure 9. Map of NPS sites in the Messalonskee Lake watershed.

Geographically, NPS sites were located mostly on the shoreline or on roads near the shoreline, especially concentrated at the north end of the Lake. Most sites outside of the immediate shoreline are located on state/town roads and involved stream crossings or ditches. Many of the sites in the upper watershed are associated with Belgrade Stream or its tributaries.

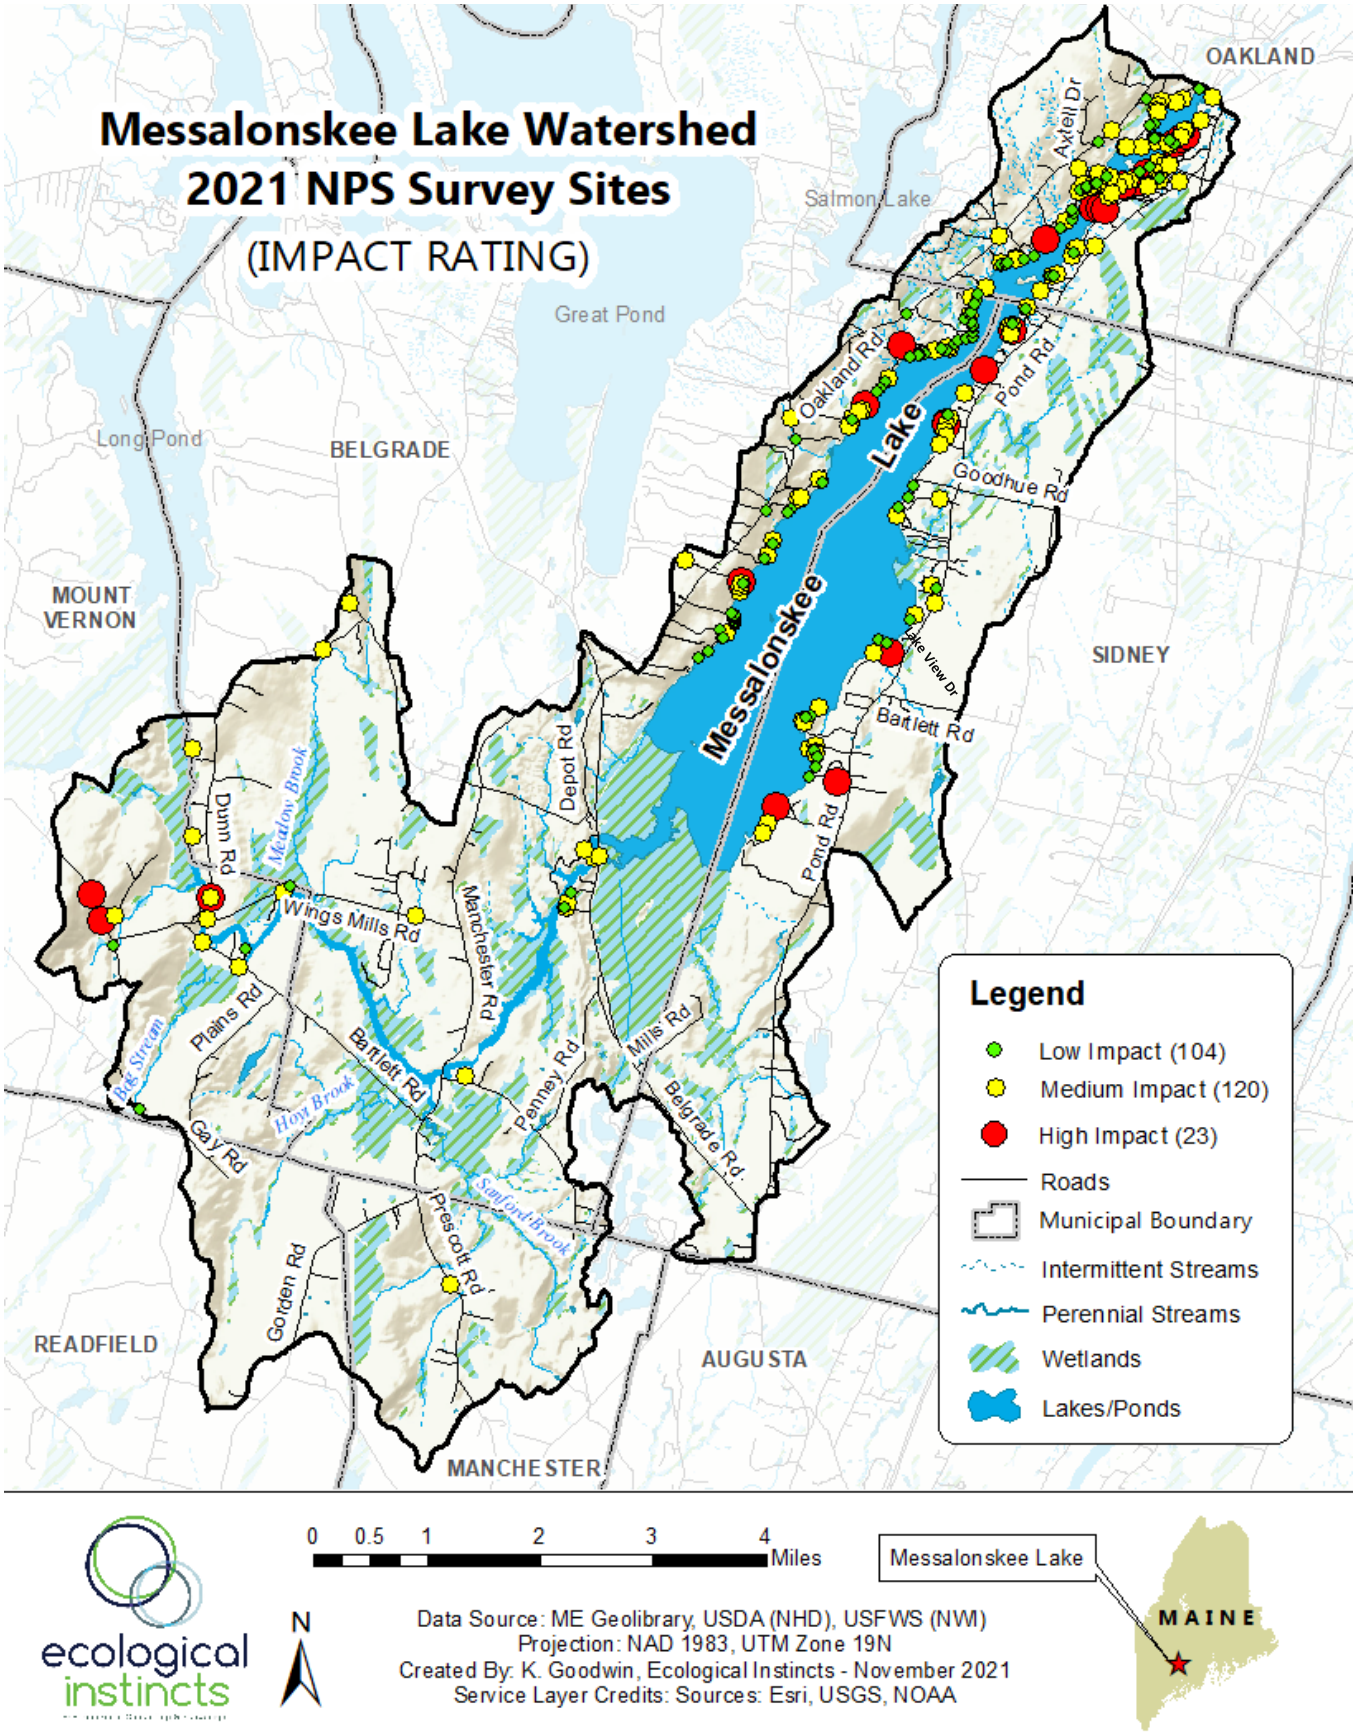
Figure 11. Map of NPS sites in the Messalonskee Lake watershed by impact ranked low to high.

The majority (91%) of sites are medium- or low-impact, while only 9% of sites are high-impact. High-impact sites are primarily associated with private roads and town roads (43%), residential development (17%) and driveways (17%). Maps showing NPS results by sector, land-use type and impact are presented in Appendix C.
